PUBLIC WORKS CENTER PEARL HARBOR FLEET MOORINGS UNDERWATER INSPECTION REPORT

SEPTEMBER 1983

OCEAN ENGINEERING
AND CONSTRUCTION PROJECT OFFICE
CHESAPEAKE DIVISION
NAVAL FACILITIES ENGINEERING COMMAND
WASHINGTON, D.C. 20374

FPO-1-83(22)

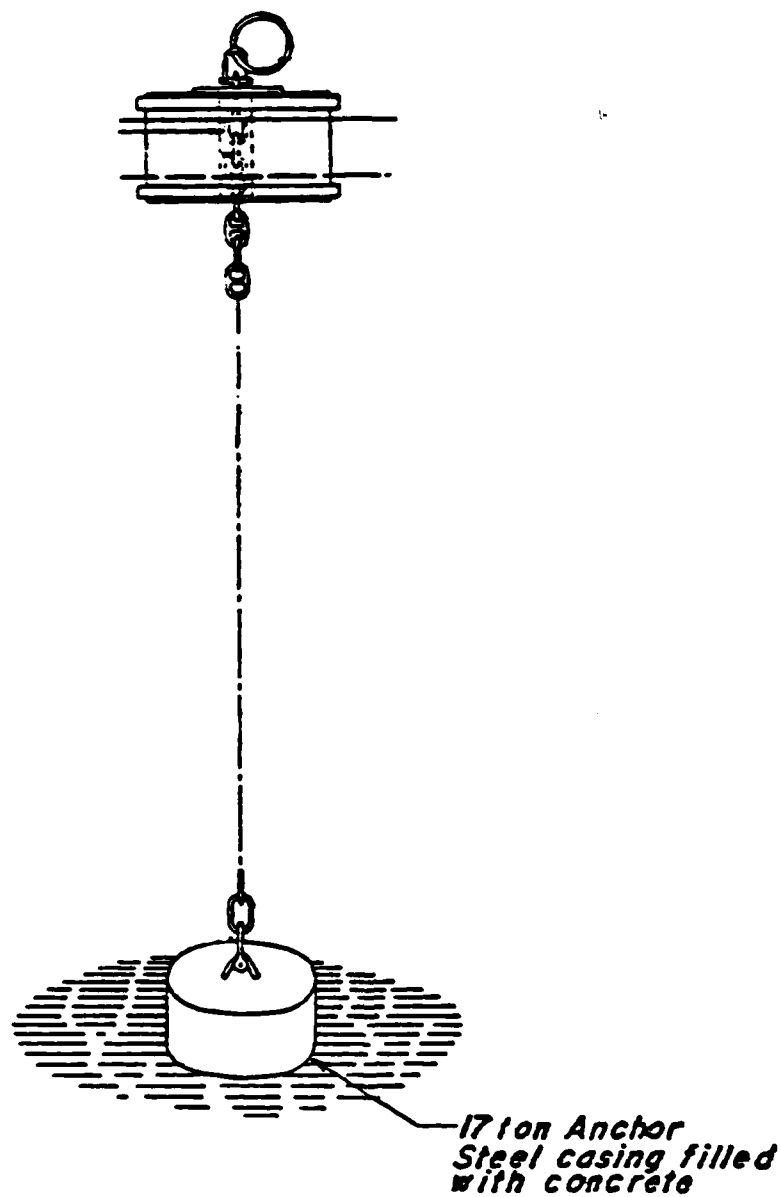
**MOORING CMN
SCHEMATIC DRAWING**

* RISER CHAIN SIZE MEASURES 2" (5/8")

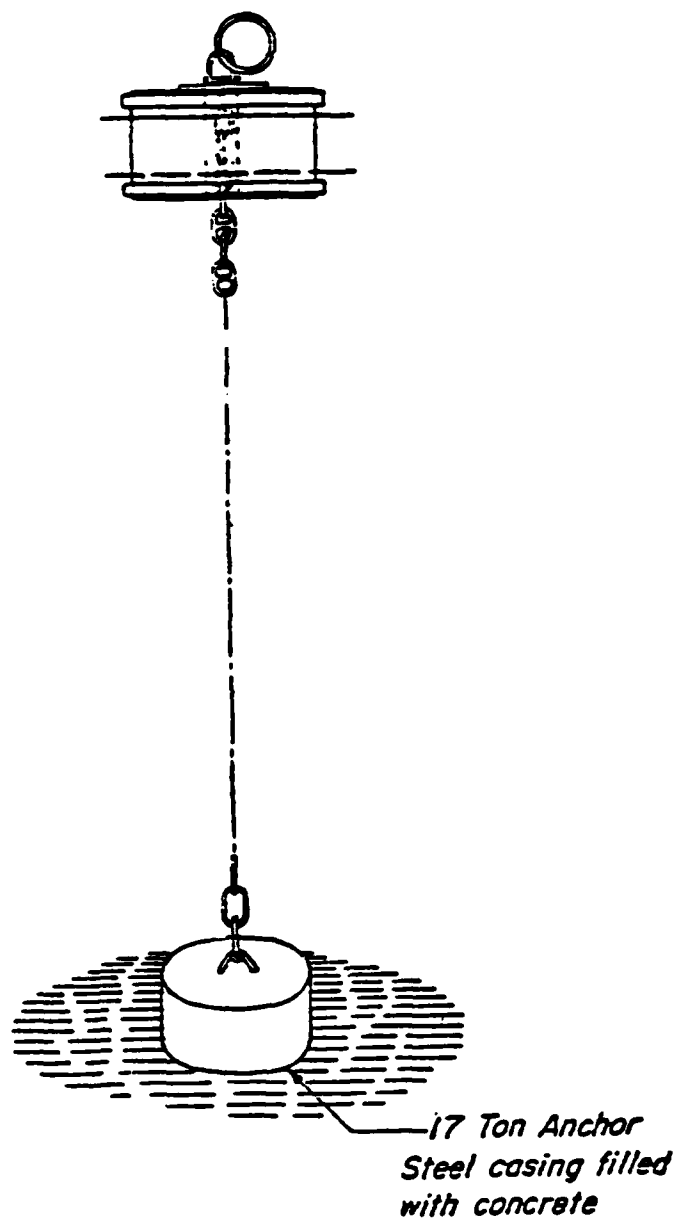
**MOORING CMM
SCHEMATIC DRAWING**

- o Three moorings (AM13, AM13A, and CMM) were found to be in poor condition with each having at least one major deficiency.
- o Cathodic protection systems are not installed on any of the moorings.
- o All of the moorings are in relatively shallow water with the majority being in 30 feet of water or less.
- o Six of the buoys (AM13, D2N, D3N, D10M, D12N, and D12M) have medium-to-heavy rust on their top deck plates.
- o The riser chains of 11 moorings were measured to be less than 80 percent of their original wire diameters.

* RISER CHAIN SIZE MEASURES 2" (5/83)

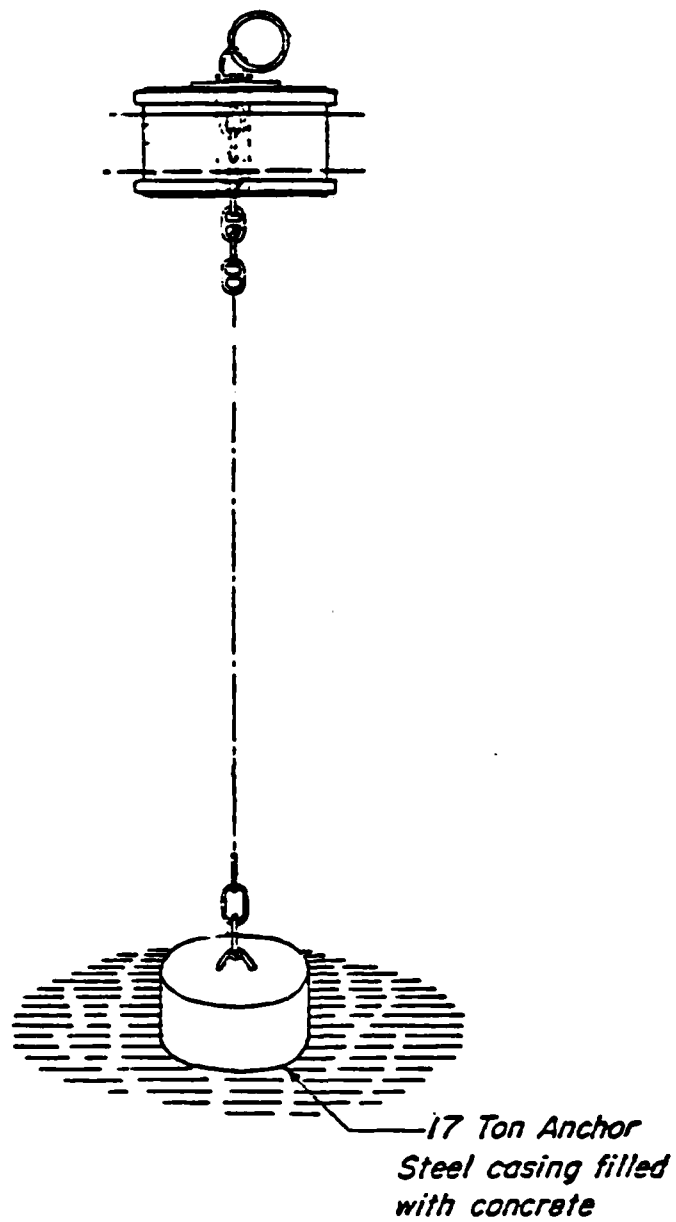
**MOORING CMS
SCHEMATIC DRAWING**

* RISER CHAIN SIZE MEASURED 2" BY DIVERS (5/83)

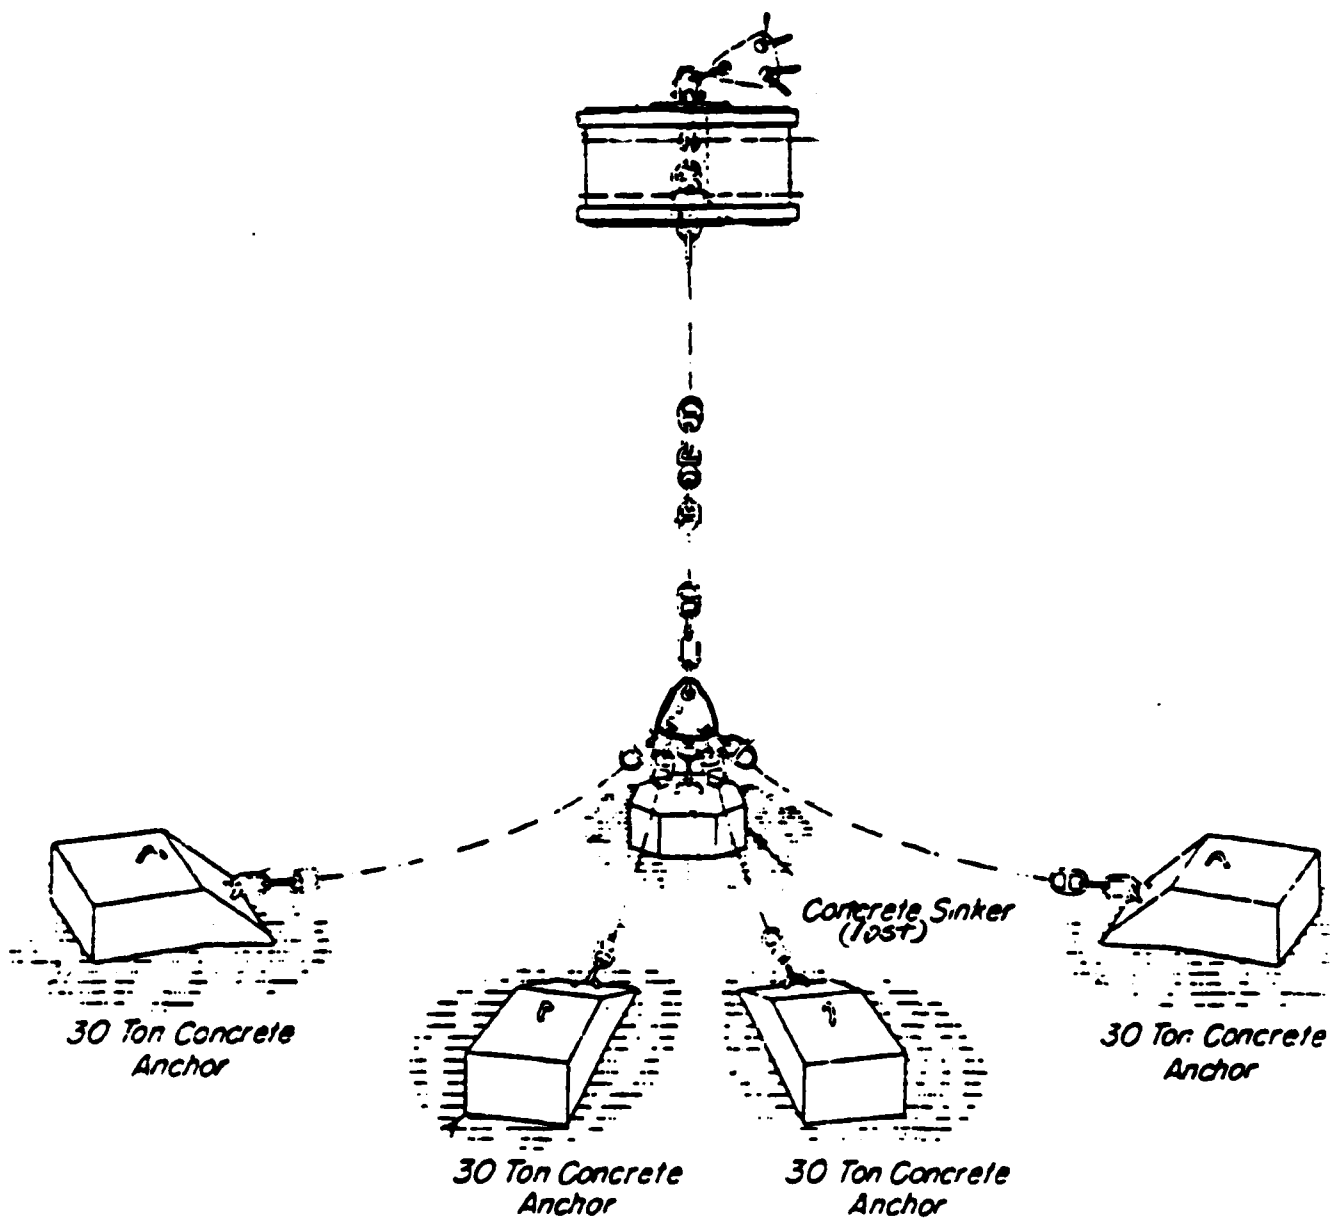
**MOORING D2N
SCHEMATIC DRAWING**

**Riser worn to 1 1/4 inches from original 2 3/4 inches (45 percent). Downgrading to F class mooring recommended.

- o Of the 18 moorings found to be in good condition, 14 were overhauled during the past 18 months.
- o Of the 21 moorings found to be in fair condition, only one should be downgraded. Mooring D2N has excessive riser chain wear and should be downgraded from a class D to a class F mooring. The other 20 moorings reveal significant chain wear, but because oversize chain was used in the as-built configurations, they still meet the requirements set forth in DM-26 for their particular class designations.

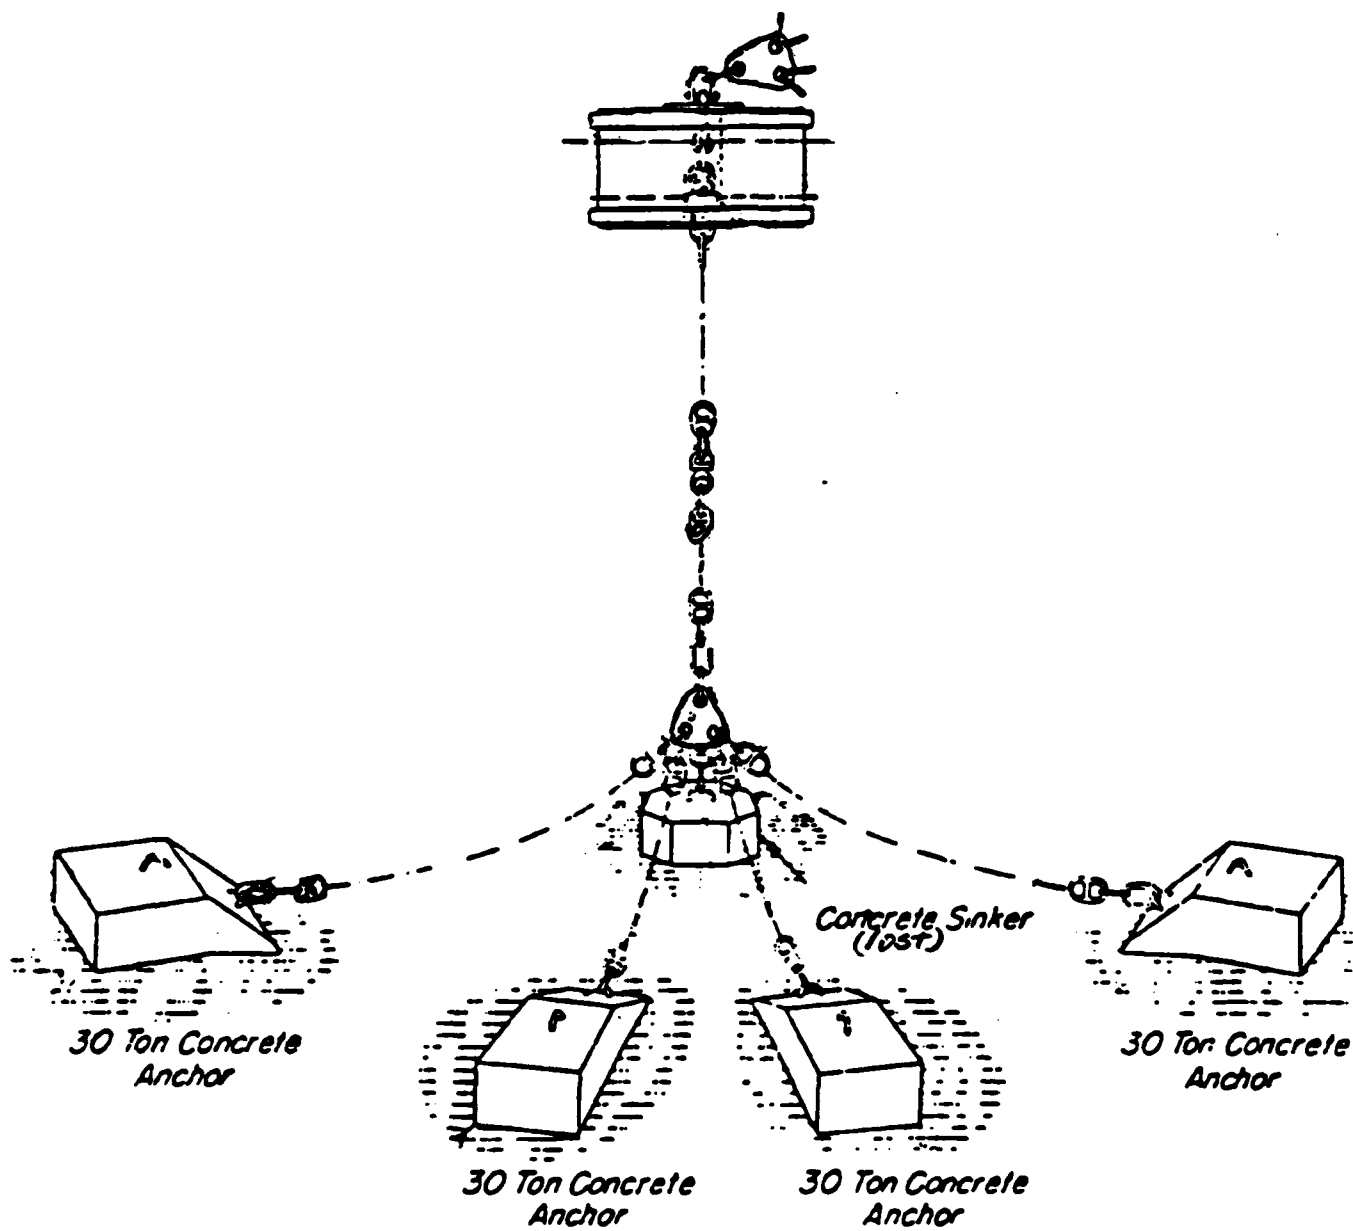
MOORING D2S
SCHEMATIC DRAWING

** RISER CHAIN MEASURED 4" BY DIVERS (5/83)

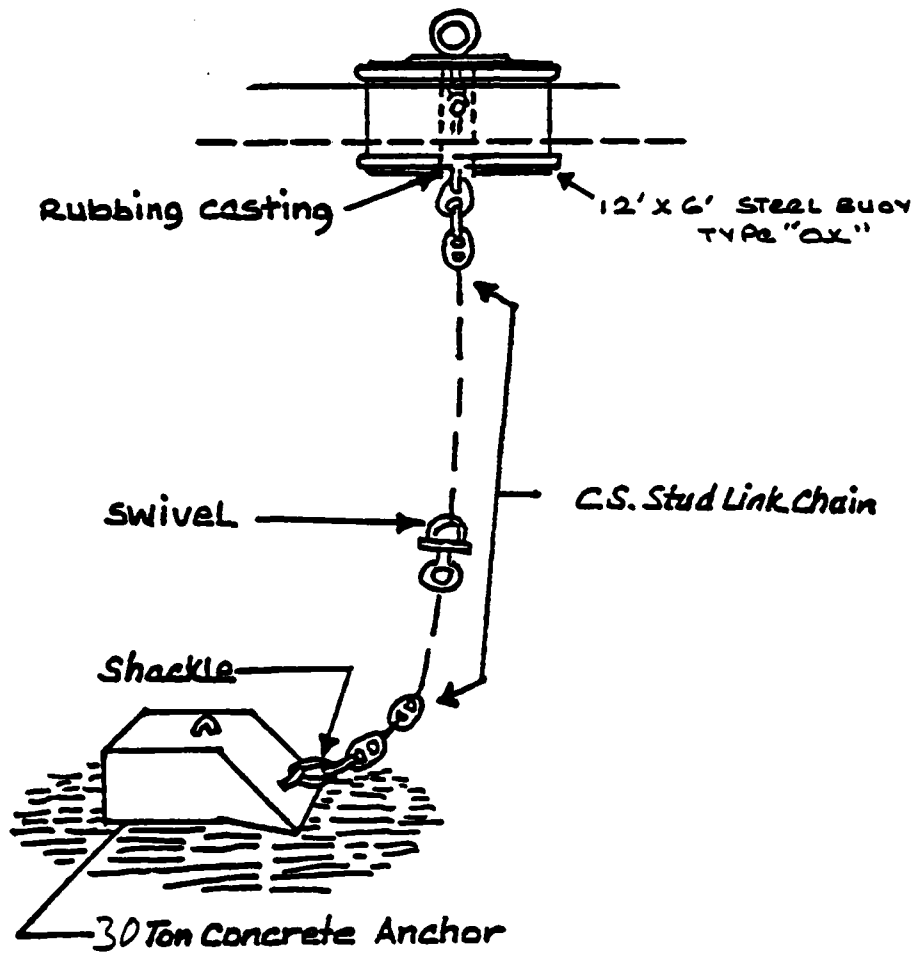
MOORING D5N

- o Buoy D11S is the only one which was found to have a tension bar. The other 41 buoys contained hawsepipes.
- o The exterior of Buoy D5N shows evidence of damage, and the buoy is riding on its side (a 90-degree list). The internal watertight integrity of this buoy is highly questionable.

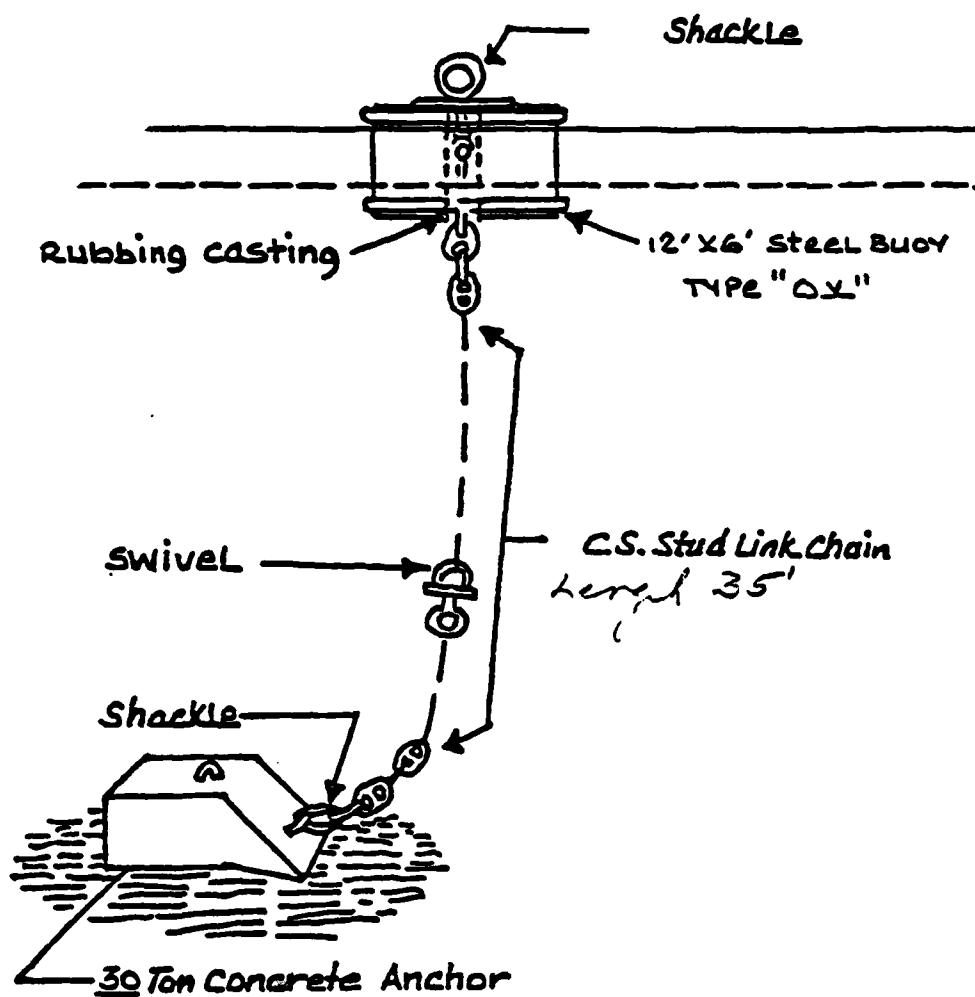
MOORING D8S
SCHEMATIC DRAWING

As a result of the passage of Hurricane Iwa through Pearl Harbor on 23 November 1982, mooring D8S failed and a number of others were displaced various distances. A number of the moorings in the Middle Loch (D5N, D5M, D5S, D6N, D6M, and D6S) are not currently in the intended positions as shown in Figures 2 through 4. When funds become available, these displaced moorings will be reinstalled in their correct locations. PWC Memorandum 1011 of 30 November 1982, a copy of which is contained in Annex C, is a report on the effects of the hurricane on the positions of the installed fleet moorings.

(*) Overhaul accomplished by Contr. N62471-82-C-2164;
Necessitated when mooring failed due to high winds during passage of
Hurricane Iwa 11/25/82;
This mooring done vice DIM of original contract.

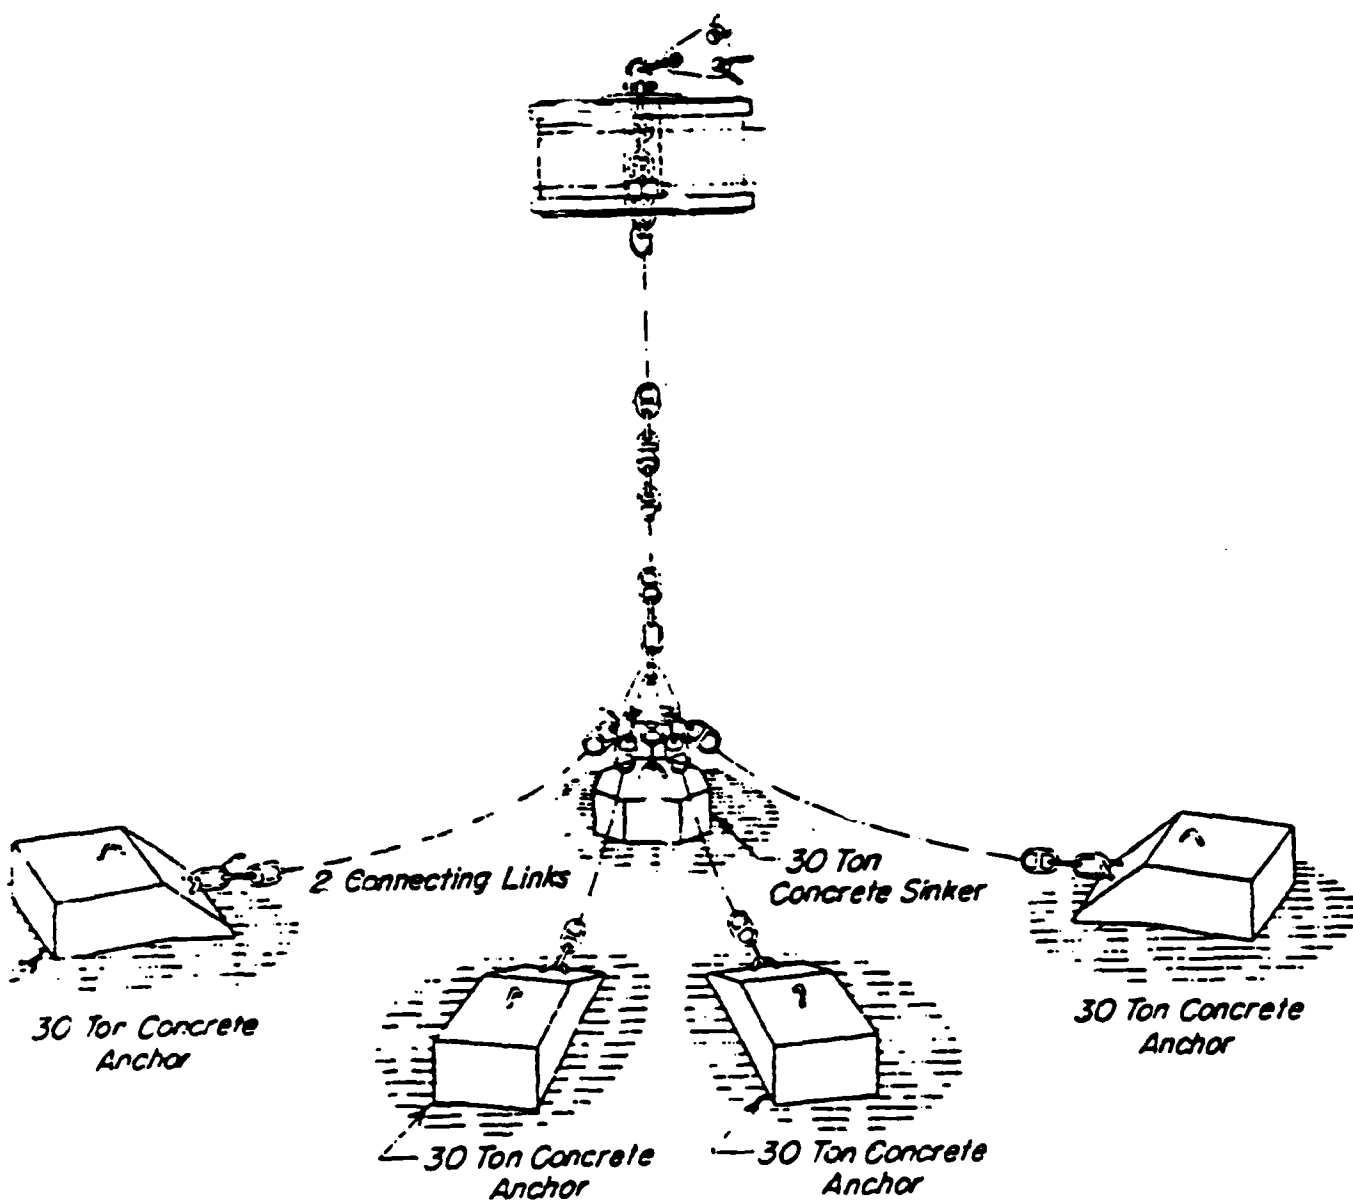
**MOORING D11N
SCHEMATIC DRAWING**

- o The ground legs of all but portions of three moorings were completely buried in the bottom.
- o Although the exterior of Buoy D11N appears to be in satisfactory condition, its internal integrity is questionable since the buoy is floating on its side.

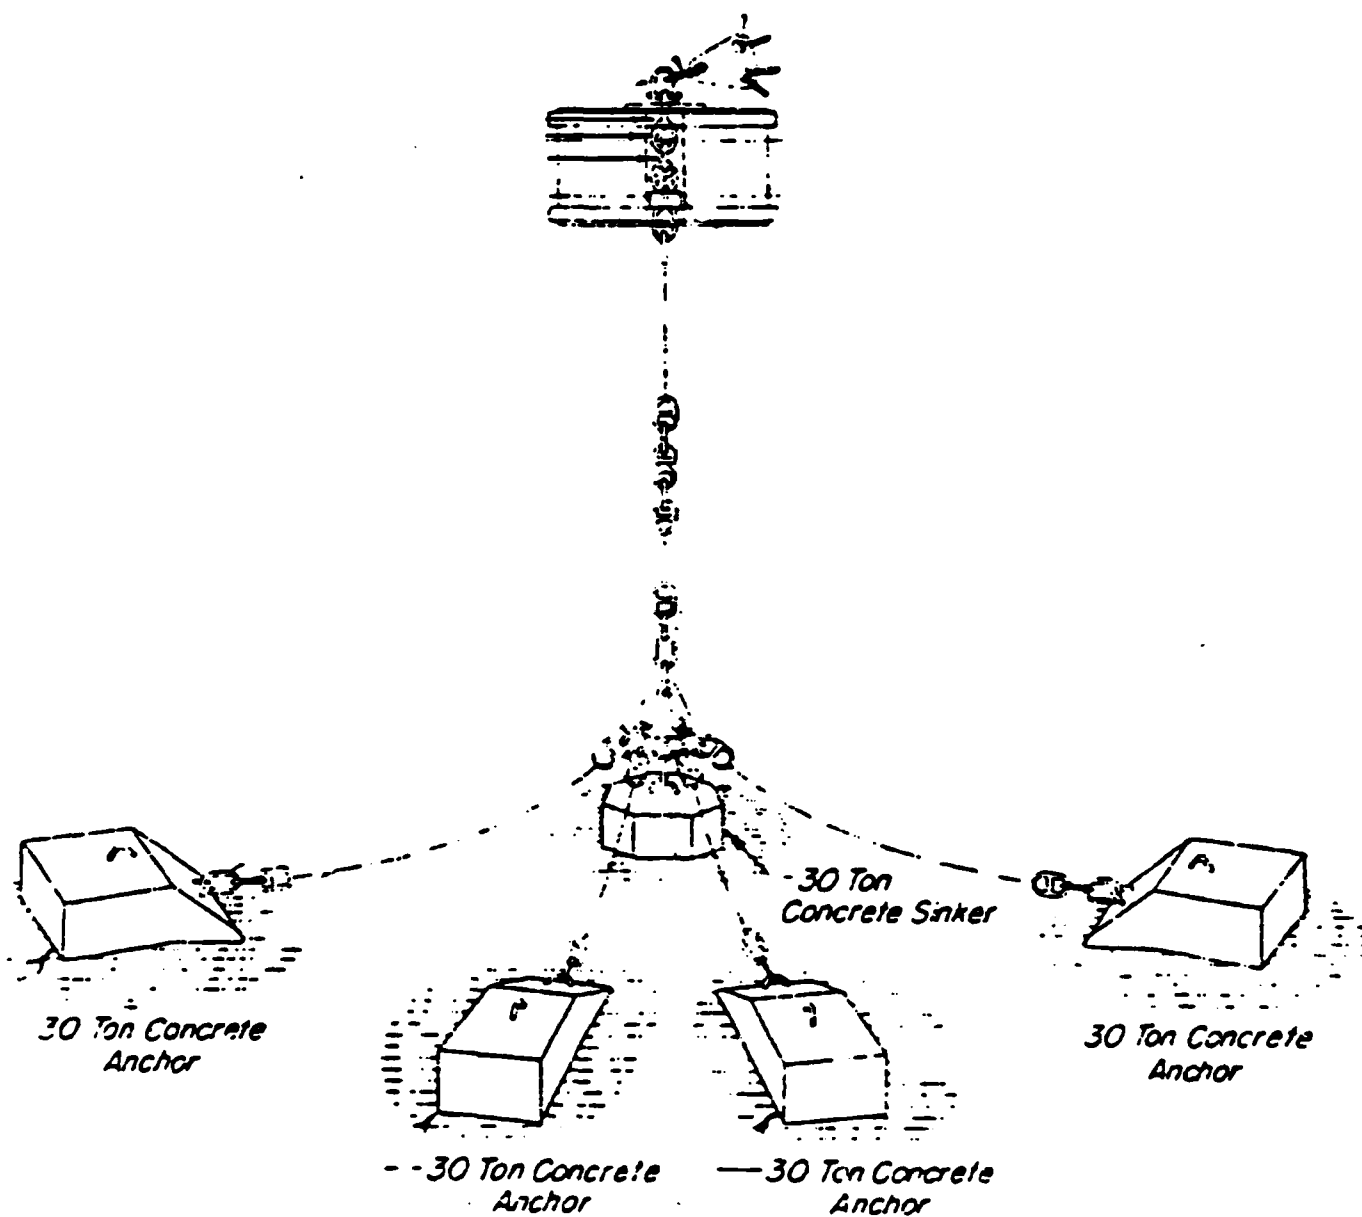
**MOORING D12N
SCHEMATIC DRAWING**

- o The top link of the riser chain in Mooring D12N is worn to less than 75 percent of its original wire diameter. This mooring buoy has a 60-degree list, and its chafing rail has rusted away.

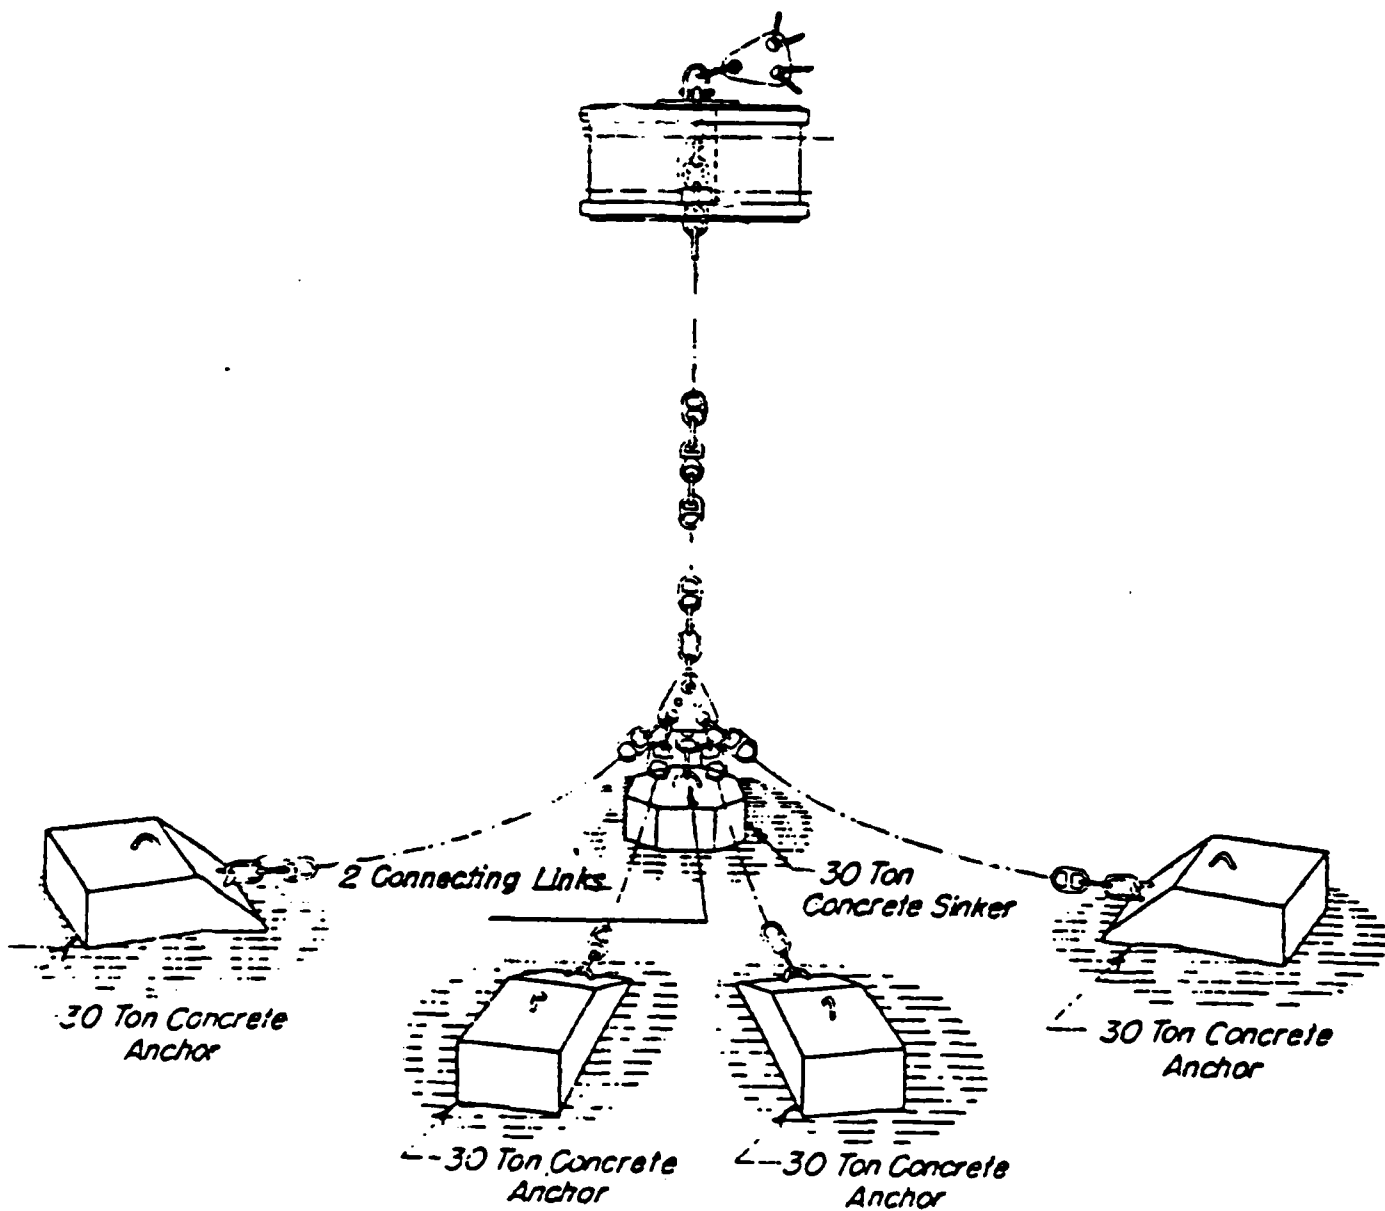
**MOORING D12S
SCHEMATIC DRAWING**

- o The fenders of five mooring buoys (AM13A, D5N, D6M/6S, D11M, and D12S) are either damaged, loose, or missing sections.

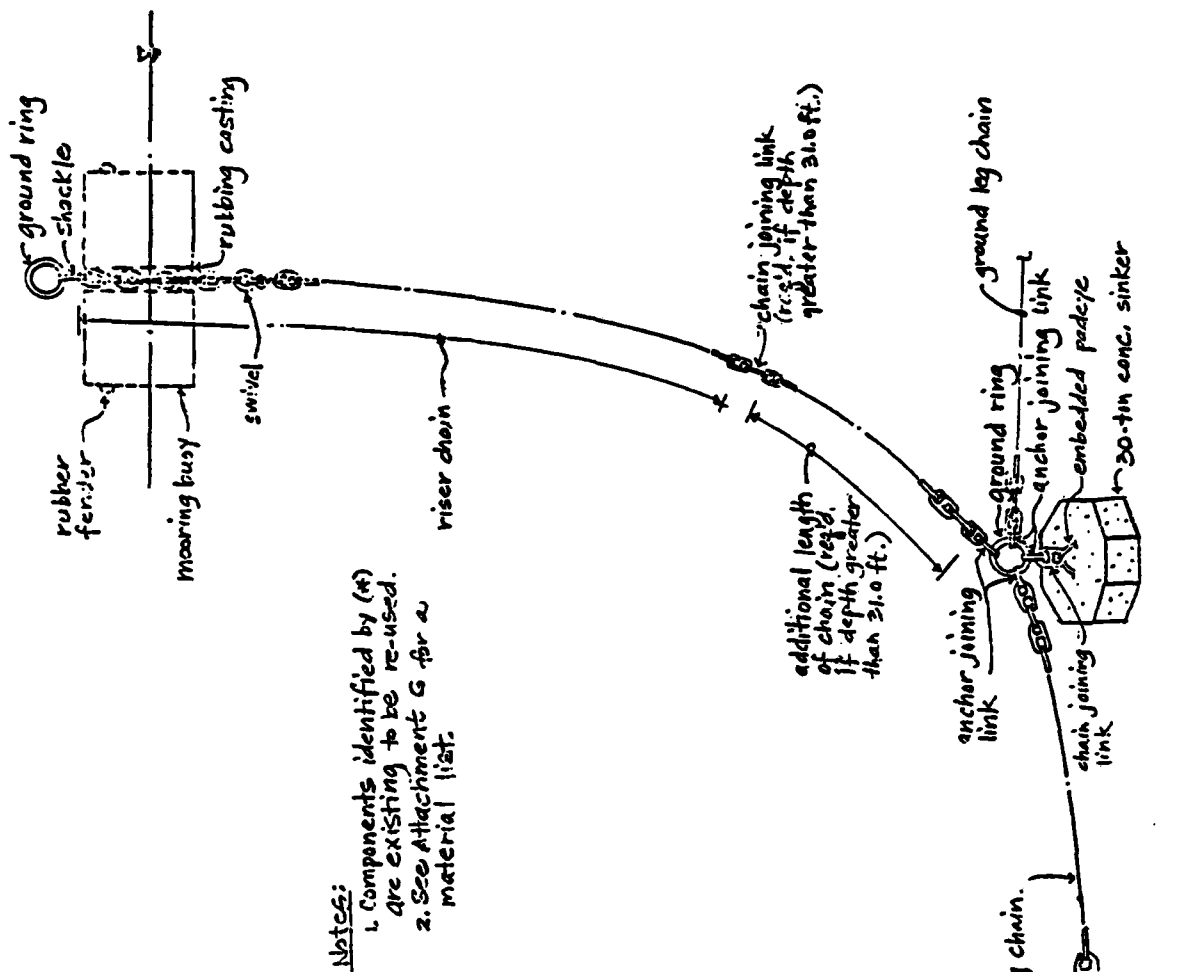
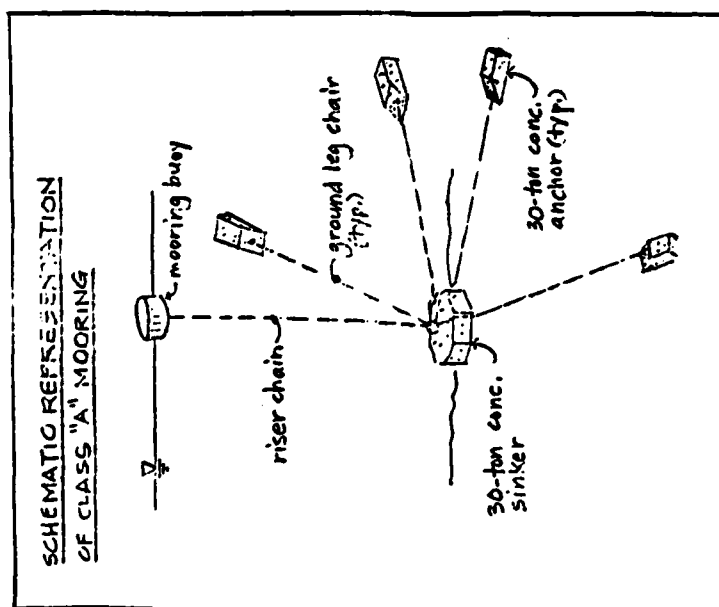
This is a 12-foot-diameter, 6-foot-high drum-type buoy with a hawsepipe. The buoy is fiberglass coated and has two rubber fenders and a galvanized pipe chafing rail. The mooring was overhauled in March 1982, and the buoy is in good condition. The top jewelry wire diameter measurements were all greater than 90 percent of their original diameter size. The chafing rail is lightly rusted, and the bottom is covered with 2 inches of marine growth.

The riser chain and accessories were replaced during the 1982 overhaul with oversized 4-inch chain in order to moor LHA/CV class ships. The riser is in good condition with all wire size measurements greater than 90 percent of original diameter. The riser enters the bottom at a water depth of 40 feet.

This mooring is in satisfactory condition for continued use as a class C mooring.

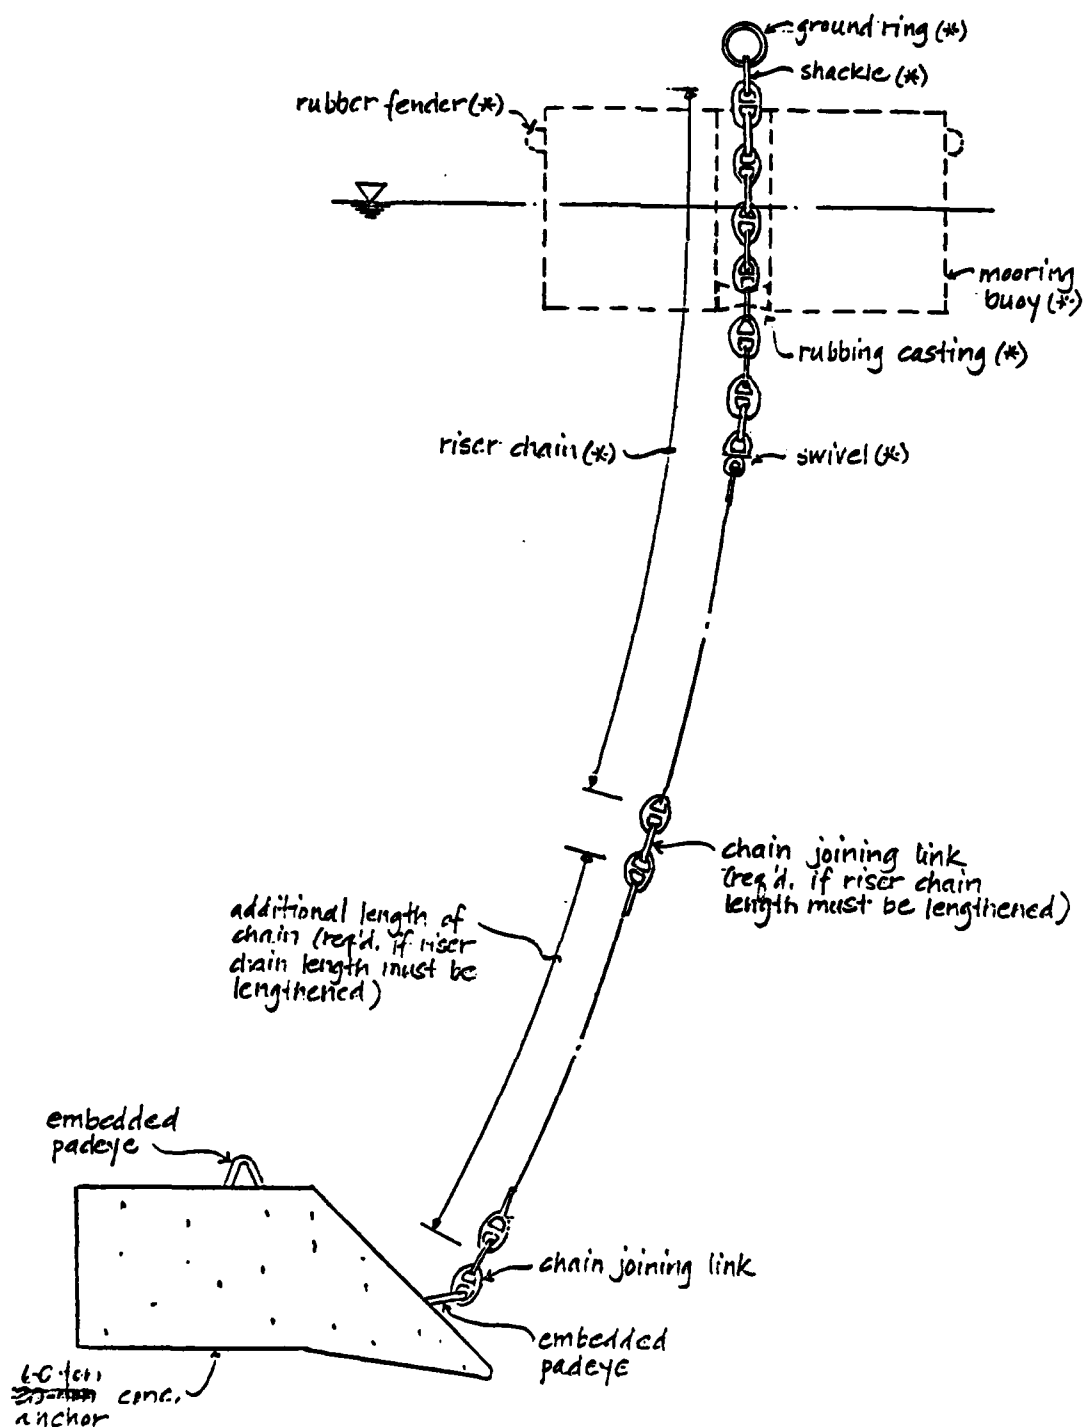
**MOORING DP2N
SCHEMATIC DRAWING**

This is a 12-foot-diameter, 6-foot-high drum-type buoy with a hawsepipe. The buoy is fiberglass coated and has two rubber fenders and a galvanized pipe chafing rail. The mooring was overhauled in March 1982, and the buoy is in good condition. The top jewelry wire diameter measurements were all greater than 90 percent of their original diameter size. The bottom is covered with 2 inches of marine growth.

The riser chain and accessories were replaced during the 1982 overhaul with oversized 4-inch chain in order to moor LHA/CV class ships. The riser is in good condition with all wire size measurements greater than 90 percent of original diameter. The riser enters the bottom at a water depth of 40 feet.

This mooring is in satisfactory condition for continued use as a class C mooring.

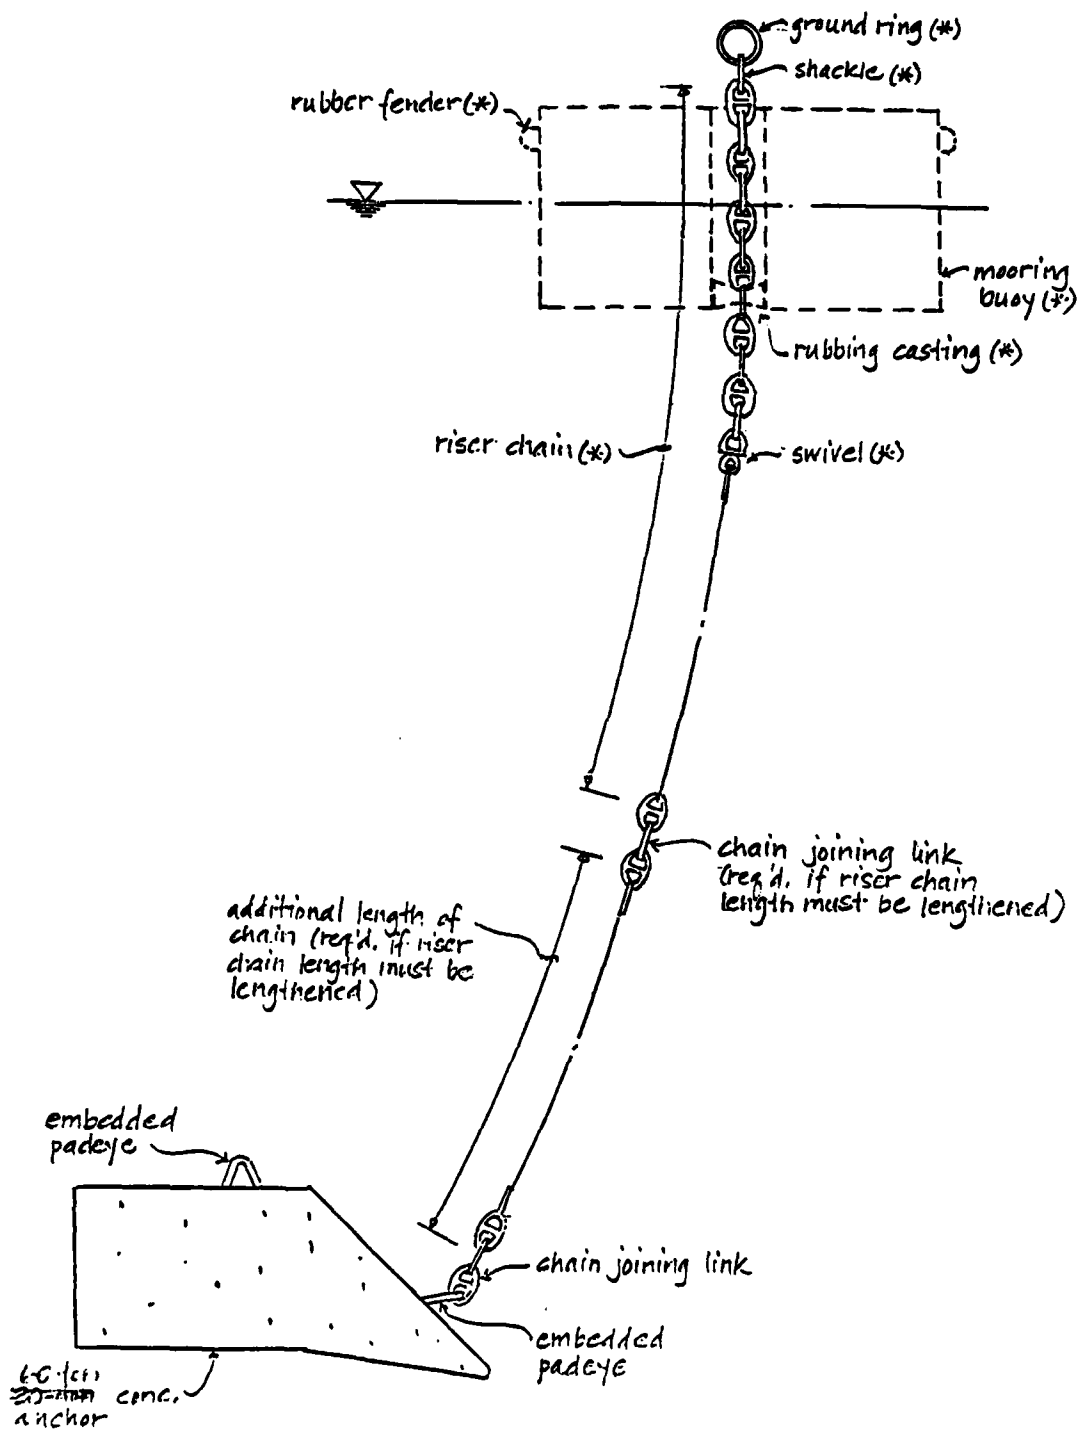
**MOORING DP2S
SCHEMATIC DRAWING**

This is a 12-foot-diameter, 6-foot-high drum-type buoy with a hawsepole. The buoy is fiberglass coated and has two rubber fenders and a galvanized pipe chafing rail, all in good condition. The top metal plate and top hardware are also in good condition.

Based on visual inspection of the buoy and riser, the mooring appears to be in satisfactory condition for use as a class F mooring.

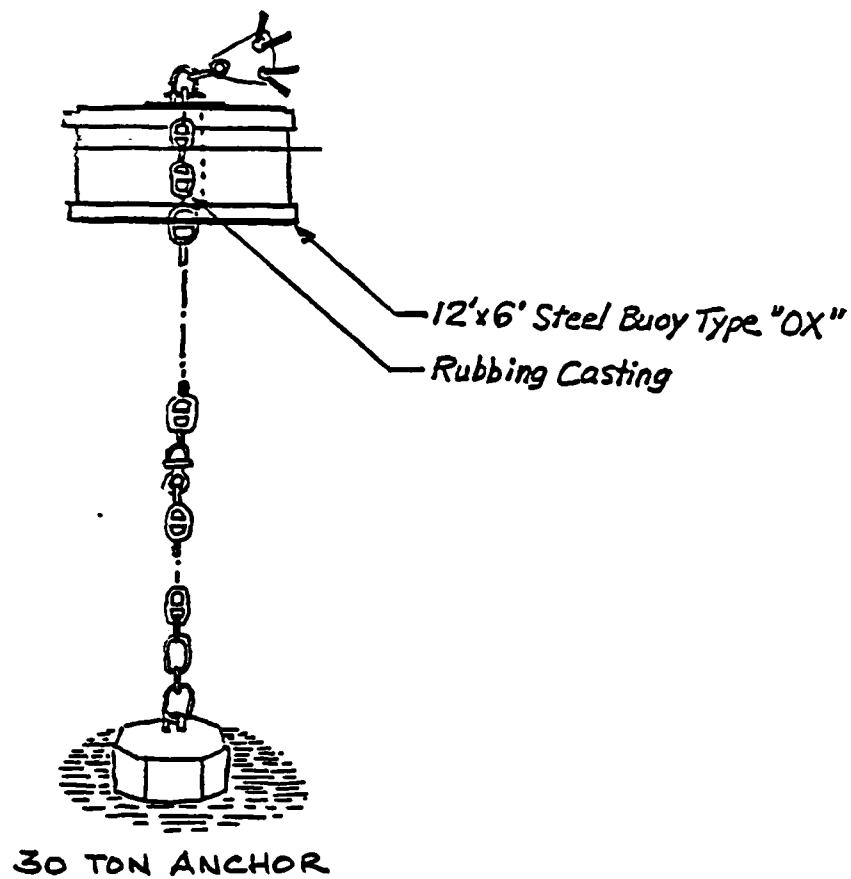
MOORING T1N
SCHEMATIC DRAWING

(*) Down-graded to Class G after 1979 U/W Insp.
